# Lake Champlain Basin Fish Passage Initiative 2008- Final report

Lake Champlain Research Institute and Center for Earth and Environmental Science  
SUNY Plattsburgh

## **Project Summary:**

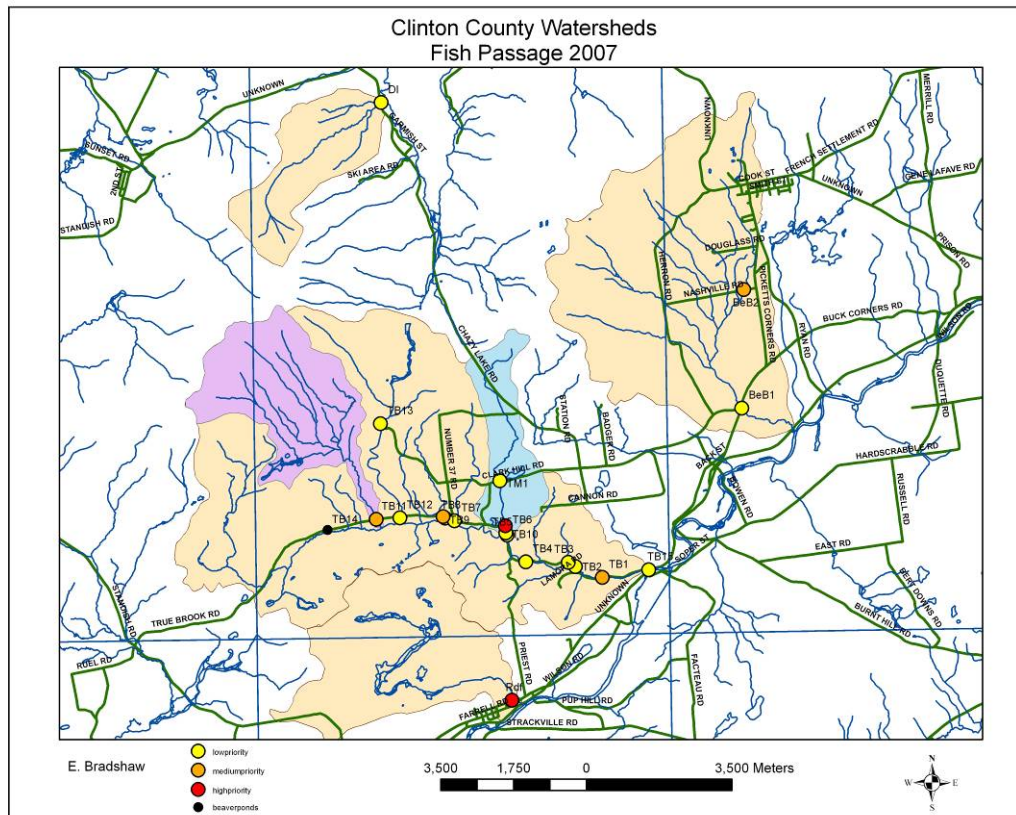
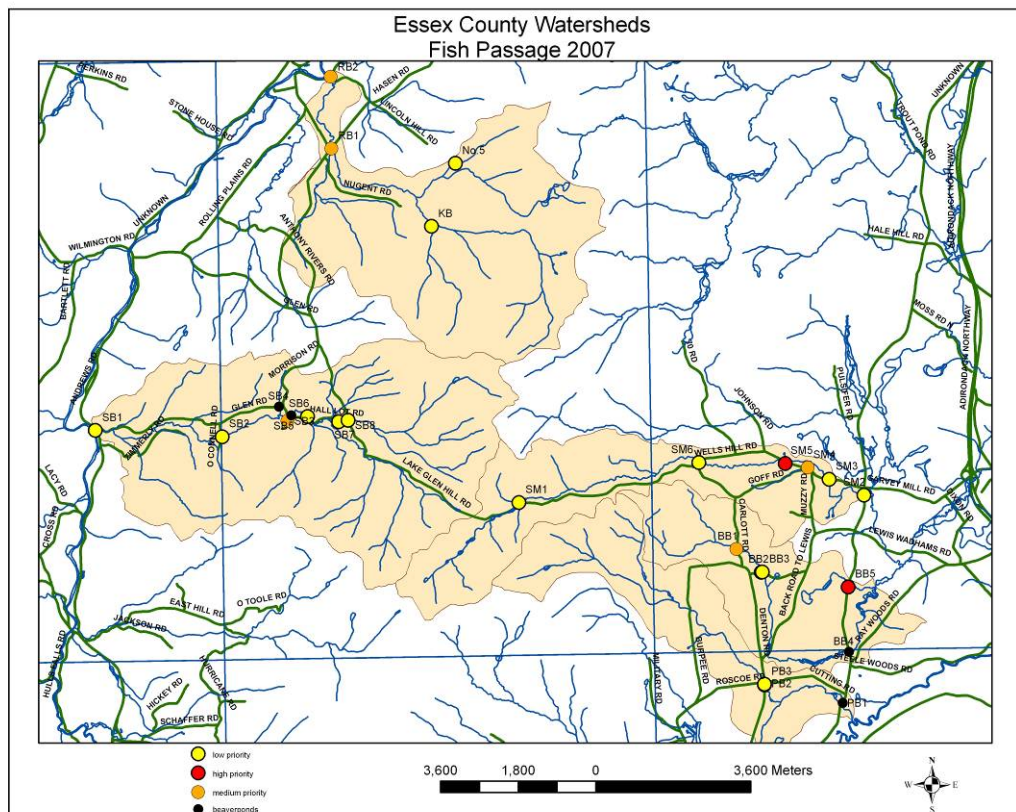
In Clinton County we assessed 20 road structures in four watersheds (Behan, Deep Inlet, Mud Pond, True Brook; Figure 2). Of 20 sites, 2 rated as high priority for impairing fish passage with 4 rated as medium priority. True Brook was the largest watershed in this study with 14 crossing sites and one high priority site. This site was listed as high priority due to the outlet drop exceeding 8 inches.

In Essex County, 27 road structures were assessed in 5 watersheds (Burpee, Phelps, Spruce Mill, Styles, and Rocky Branch; Figure 2). There were 2 high priority and 5 medium priority sites for impaired fish passage in Essex County. The two high priority sites were also a result of outlet drop, in one case a 6 ft drop from the structure to stream bed.

Figure 2. Clinton (top panel) and Essex (bottom panel) road crossing site scores for fish passage. Site color codes are described in Table 2.

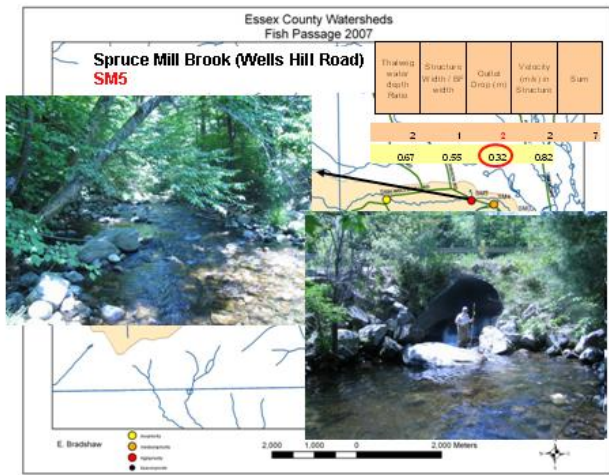
Figures 3 and 4 depict examples of two typical high priority sites for barrier replacement in a culvert (Fig. 3) and a concrete box culvert (Fig. 4). These examples illustrate the raw data and scoring system used to prioritize sites. In both cases the site rates as a high impact on fish passage due to both the outlet drop and cumulative score for all variables.

Figure 3. Study site SM 5 on Spruce Mill Brook in Essex County. Raw data plus site scores.

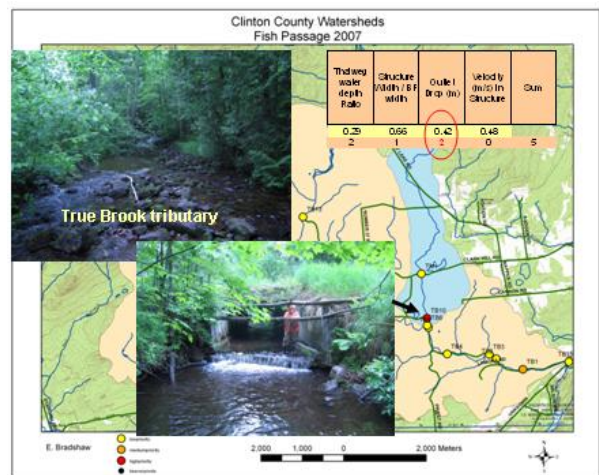
Figure 4. Study site TB10 on True Brook in Clinton County. Raw data plus site scores.
