*Upper Carson Slough Aquatic Habitat Enhancement and Restoration: Rogers
and Longstreet Springs and Outflow Restoration
Ash Meadows National Wildlife Refuge*

**National Fish Passage Program Funding
Status Report: June 2014**

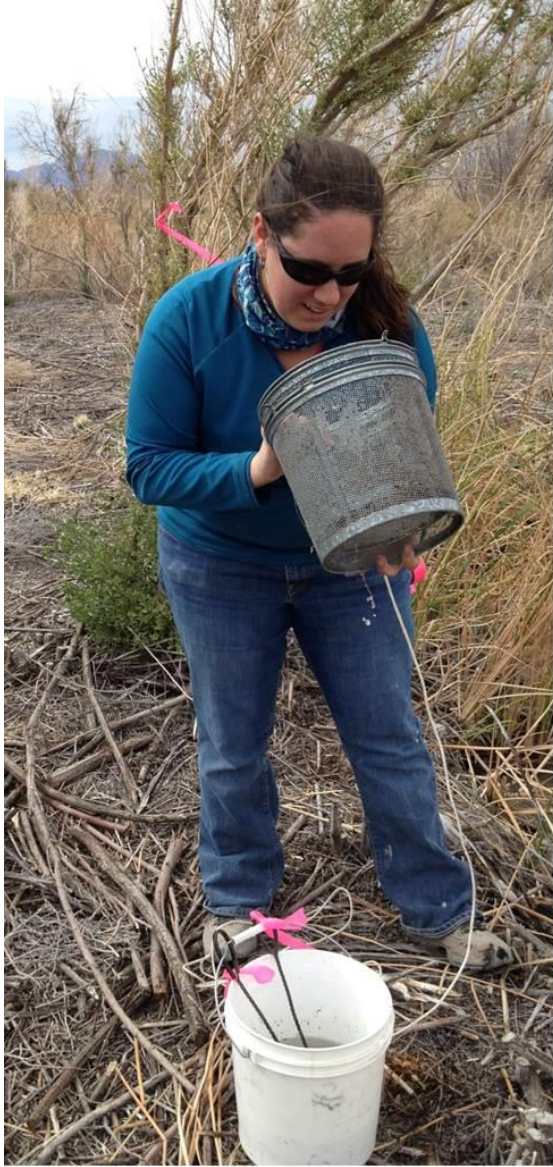
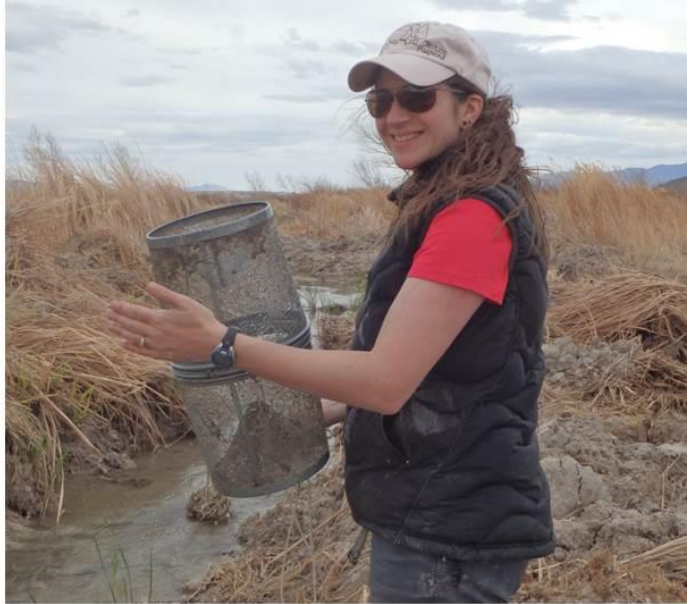
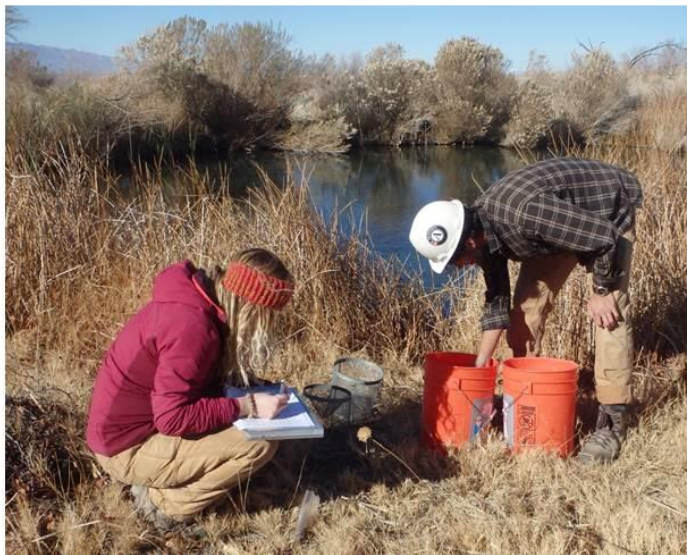
Figure 4. Fish salvage efforts conducted by Great Basin Institute contractors (left and upper right) and Nevada Conservation Corps crew members (lower left), Ash Meadows National Wildlife Refuge, NV.

Restoration activities began in December 2013 and were completed in April 2014. In order to minimize native fish loss, extensive fish salvage efforts were conducted by Ash Meadows NWR staff, Nevada Conservation Corps (NCC) crew members, and volunteers prior to dewatering or major disturbance. Fish salvage was conducted in five phases in close coordination with Rob Andress (Gradient, LLC; Figure 3). Initially, water flow was only partially diverted (30-70%) to allow time for fish trapping and relocation. Water was fully diverted following the completion

of fish salvage efforts. A total of 2,925 Ash Meadows Amargosa pupfish and 91 Ash Meadows speckled dace were captured and relocated during fish salvage events at Rogers Spring. At Longstreet Spring, 1,910 pupfish and 15 speckled dace were salvaged from the outflow channels prior to full diversion, and 6,011 pupfish salvaged from the spring pool prior to springhead alteration (Figure 4). In total, almost 5,000 crayfish, 6,900 mosquitofish, and 900 tadpoles were removed from the restoration areas.

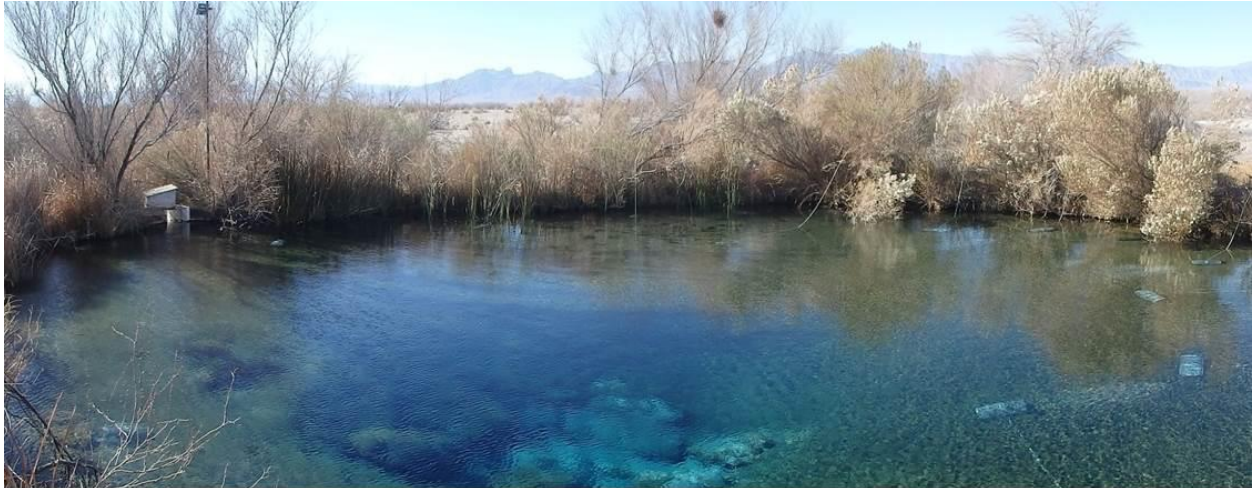
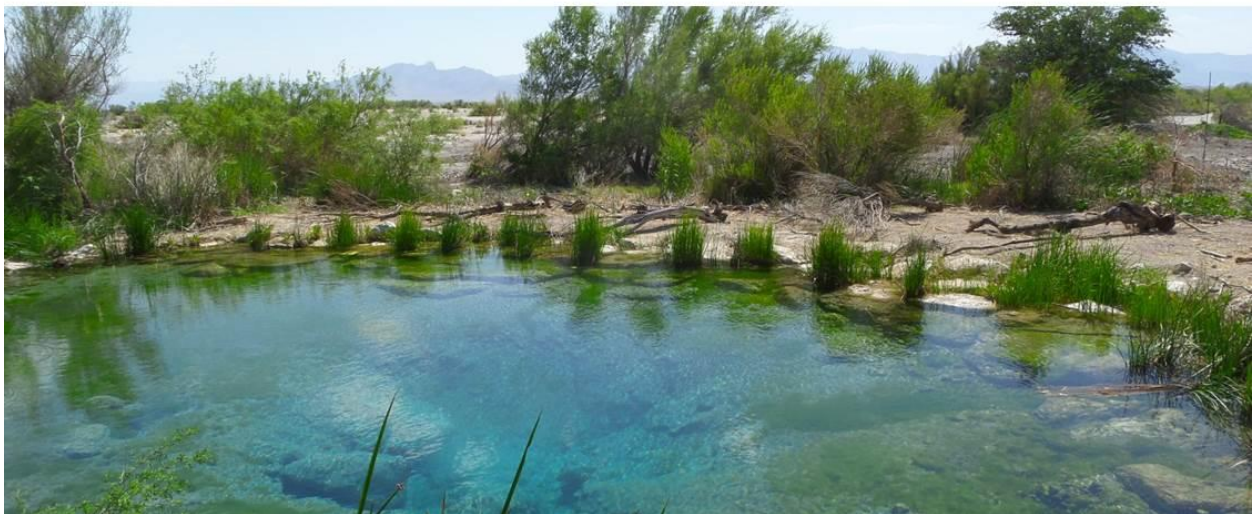
Figure 6. Longstreet Spring pool before (upper) and after (lower) restoration. Note the reduction in size and shallow marginal area by placement of caliche boulders. Ash Meadows National Wildlife Refuge, NV.

The excavation of Longstreet Spring pool for agricultural purposes resulted in a larger pool surface area and shallow shelf along the periphery. Enlarged surface area and residence time promoted heat loss from the pool and thus a reduction in temperature through the stream outflow. The shallow shelf around the spring pool encouraged invasive cattail encroachment and provides ideal habitat for aquatic invasive species. Longstreet Spring has a similar discharge rate to Kings Pool, another spring which underwent a size reduction. Kings Pool has successfully prevented the colonization of cattail stands and saw a substantial reduction in aquatic invasive animal species. Similar to methods at Kings Pool, large boulders of locally-derived caliche were placed along the shallow shelf and filled with cobbles and gravel in interstitial spaces. This helps prevent cattail growth, limits invasive animal species habitat, and provides ideal substrate for algae growth and pupfish habitat.

Approximately 5,140 meters (1,558 feet) of new stream channel was excavated [Rogers Spring = 1,830 meters (6,004 feet); Longstreet Spring = 2,035 meters (6,676 feet); lower combined channel = 1,275 meters (4,183 feet)] (Figure 5). The Longstreet Spring pool was reduced in size by approximately 50-60% to better resemble the size and shape of the spring prior to anthropogenic alteration (Figure 6). Additionally, the Longstreet Spring flume was removed for increased native fish passage between the spring pool and outflow (Figure 7). Following the completion of work on the spring pool and the removal of the flume, pupfish were sighted entering the pool and exhibiting breeding behavior along newly-placed caliche boulders (Figure 8). Speckled dace were also seen entering the pool by Rob Andress.

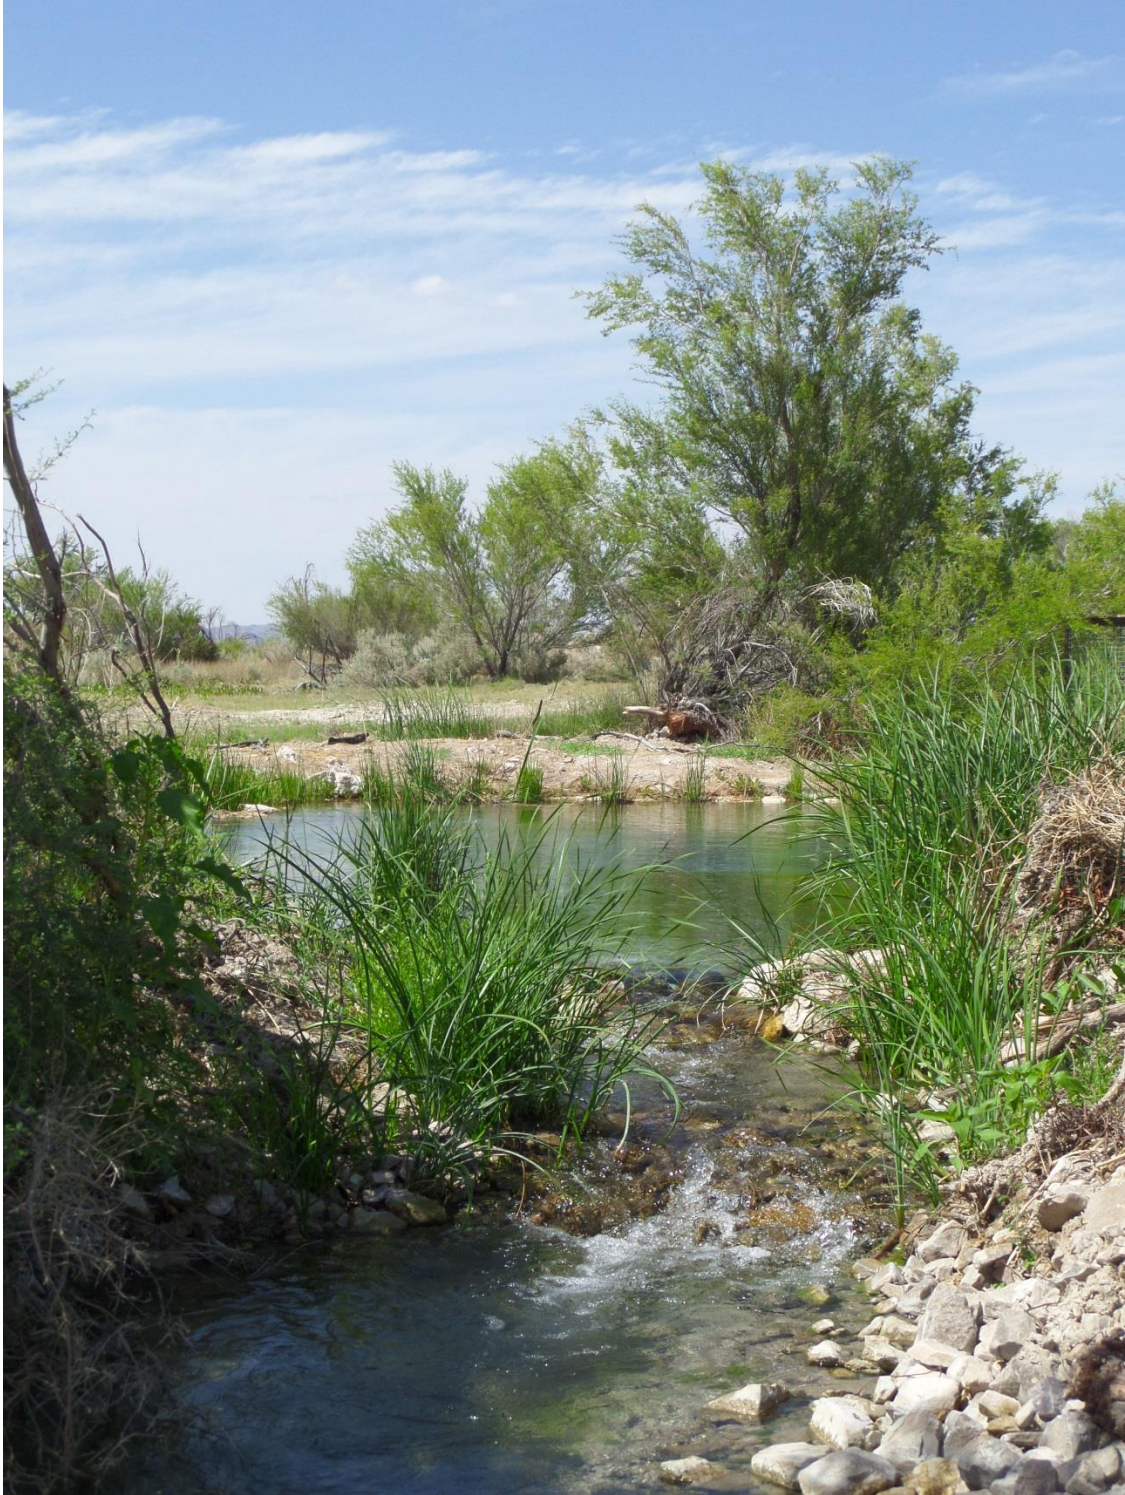
Figure 7. Outlet to Longstreet Spring pool after removal of water monitoring flume allowing full fish passage ability for native fishes, Ash Meadows National Wildlife Refuge, NV.

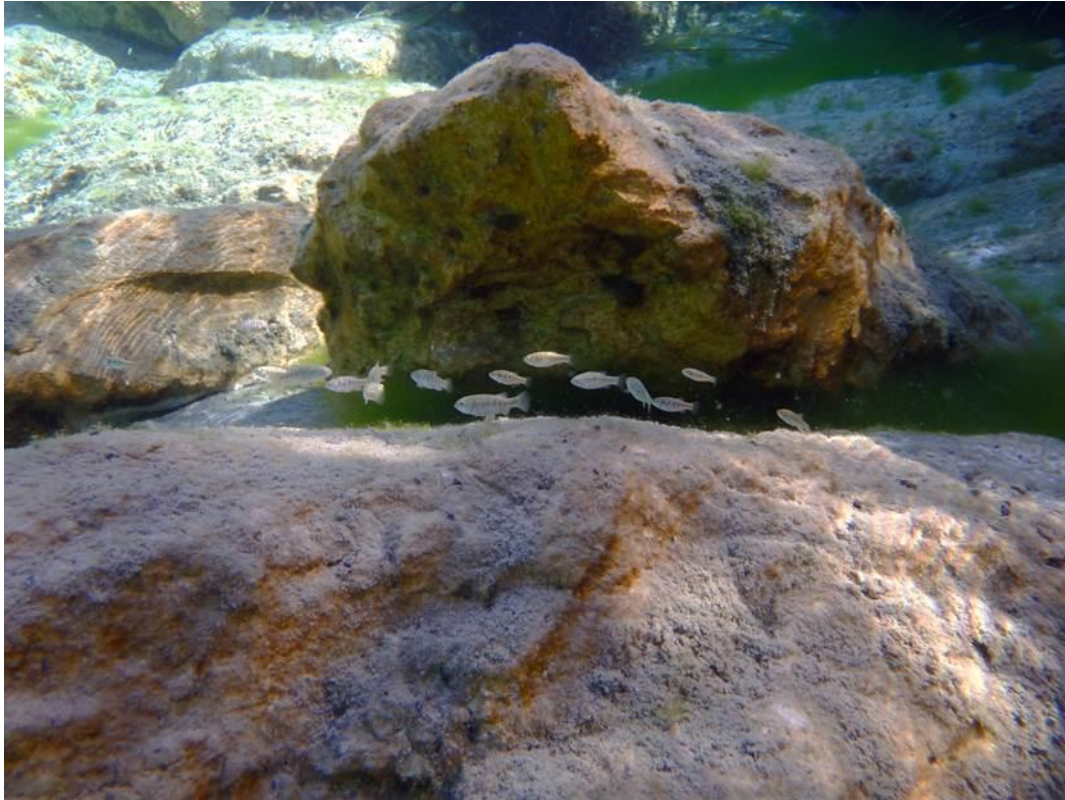
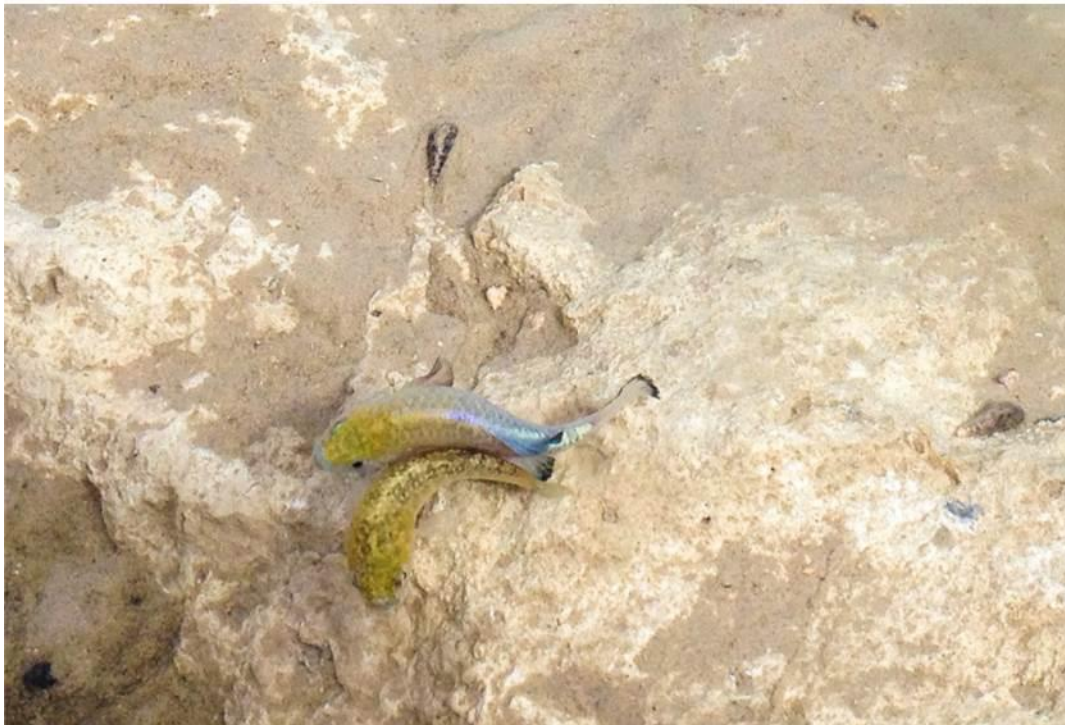
Figure 8. Ash Meadows Amargosa pupfish (*Cyprinodon nevadensis mionectes*) congregation and breeding behavior in newly-restored Longstreet Spring pool, Ash Meadows National Wildlife Refuge, NV.

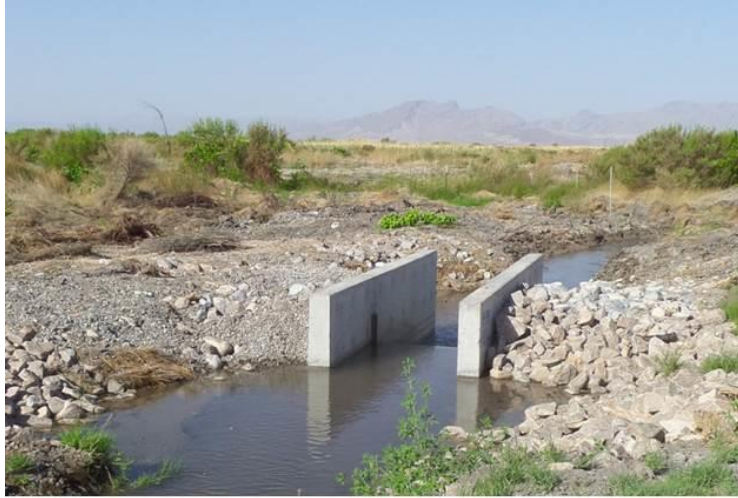
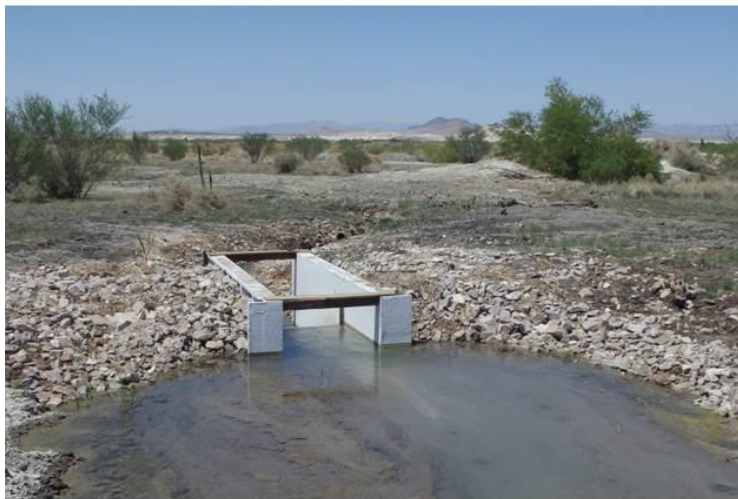
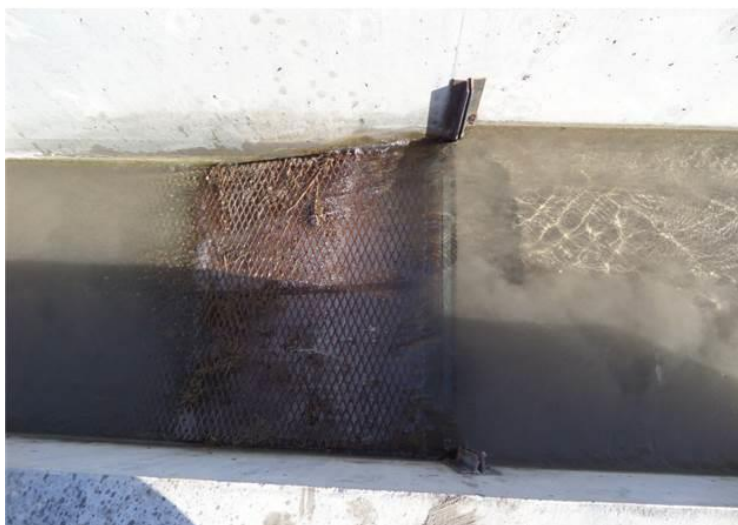
Figure 9. Fish barriers installed along restored stream channels in Rogers (upper) and Longstreet (middle) springs. Lower panel shows installation of removable plates and grate. Ash Meadows National Wildlife Refuge, NV.

Concrete fish barrier structures with removable flashboard systems were installed approximately 600 meters (2,000 feet) downstream from Rogers Spring source and 900 meters (3,000 feet) downstream from Longstreet Spring source pool (Figure 9). The concrete barriers are structured as a 3.63-meter (12-foot) long box culvert with an open top. The barrier is placed in-line with stream flow which will pass over a locking and tamper-proof flash board fish barrier, creating a vertical water surface drop of 0-1 m (0-3 feet). This temporary or removable structure allows for future invasive species treatments or invasion prevention, but also allows for free passage of endemic fishes when boards are removed for connectivity throughout all systems. A concrete channel large enough to carry full flow from Longstreet Spring was also installed approximately 30 meters (100 feet) downstream from the spring pool for water quality monitoring (Figure 10).

Unfortunately, a gravid sailfin molly was captured approximately 0.9 km (0.56 mi) from Longstreet Spring pool in March 2014. As stated previously, Longstreet Spring underwent rotenone application targeting sailfin mollies in spring 2011, and this species had not been sighted or captured since the project (Weissenfluh 2012). Darrick Weissenfluh (Ash Meadows Conservation Facility Manager) Sharon McKelvey (Refuge Manager) and Rob Andress (Gradient, LLC) were immediately notified. Temperature readings indicated that current conditions would be suitable for sailfin molly reproduction in this area. Due to the sailfin molly discovery and the amount of effort already conducted in fish salvage (2,554 trap-hours), it was decided that water flow be fully diverted to the new channel immediately. A block net was placed below Zone 2A to prevent downward movement of sailfin molly during draining. The following day, eight more individuals were captured in Zone 2B while water remained, and fish salvage continued until the area was dry. Plates were installed on the new Rogers and Longstreet Springs fish barriers to prevent potential upstream movement of sailfin mollies through the new

stream channels. Plates will remain in place until appropriate monitoring is conducted and confidence that no sailfin mollies remain in the system is attained.

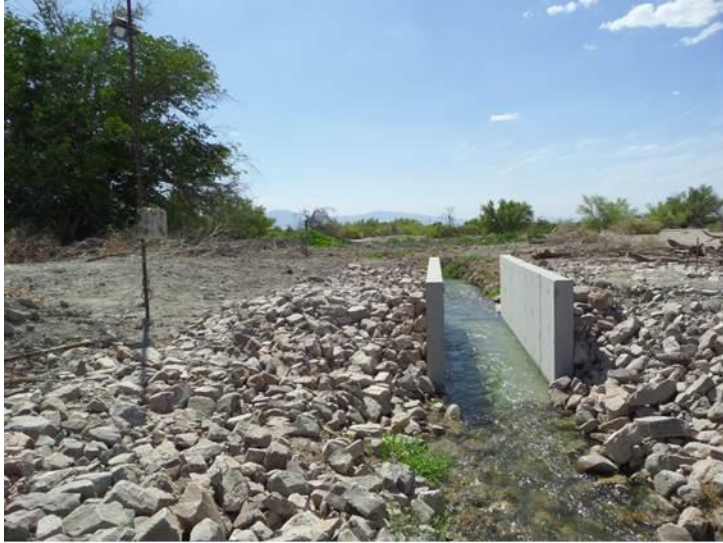
Figure 10. Concrete structure installed for water monitoring, Longstreet Spring, Ash Meadows National Wildlife Refuge, NV.

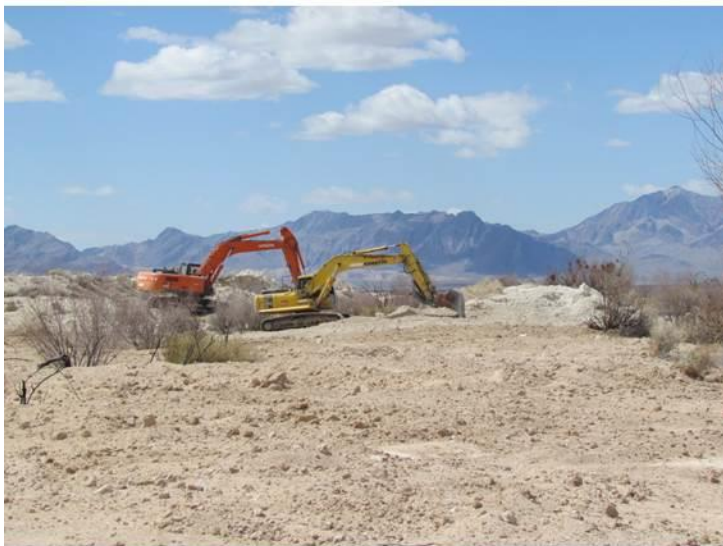
Figure 11. Berm and ditch removal in the Upper Carson Slough, Ash Meadows National Wildlife Refuge, NV. Photo courtesy of Hal Fairfield, volunteer.

Approximately 17,000 meters (56,000 feet) of berms and ditches were removed to promote the natural movement of overland and subsurface water flow throughout the Upper Carson Slough (Figure 11). Berms or ditches with substantial native plant growth (i.e., mesquite *Prosopis* spp., leatherleaf ash *Fraxinus velutina*, saltbush *Atriplex* spp.) were only partially removed if it would not significantly inhibit water movement during high flow events. A low water crossing was also constructed to maintain the accessibility of the east-west two-track road crossing Rogers Spring, just below the fish barrier (Figure 5; Figure 12). The road will not be decommissioned for the purposes of wildfire access and a future recreational trail system throughout the UCS.

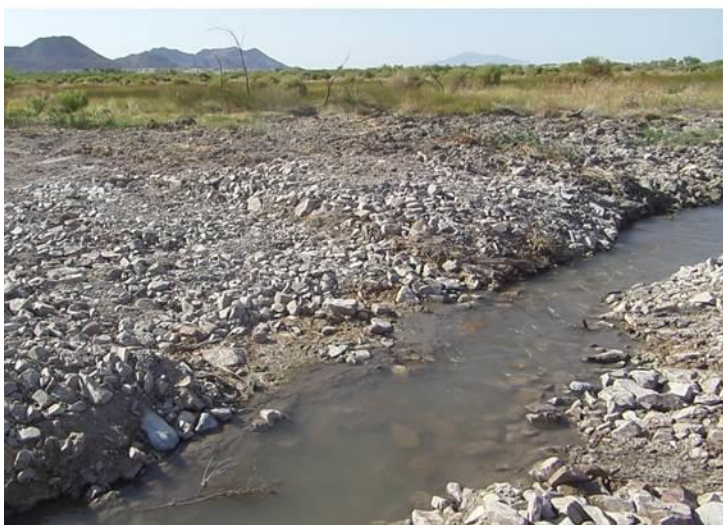
Figure 12. Low water crossing, Rogers Spring, Ash Meadows National Wildlife Refuge, NV.

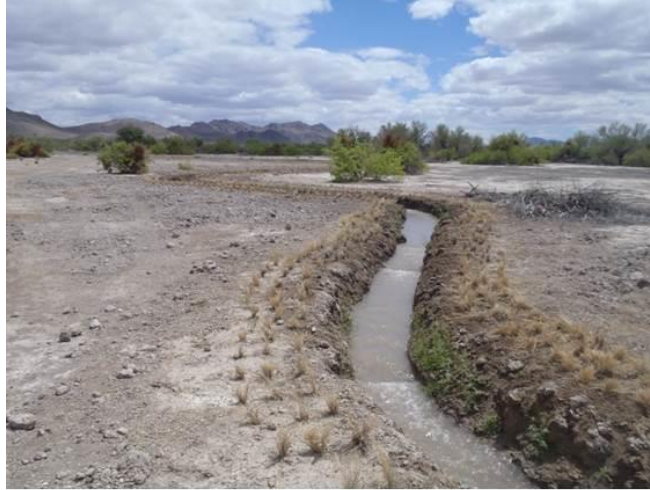
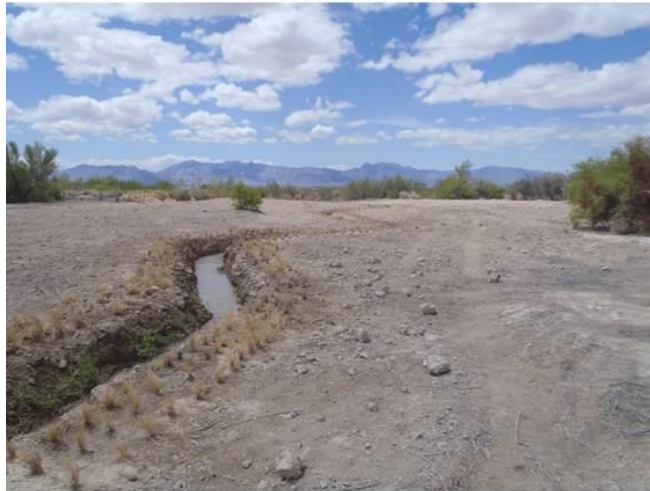
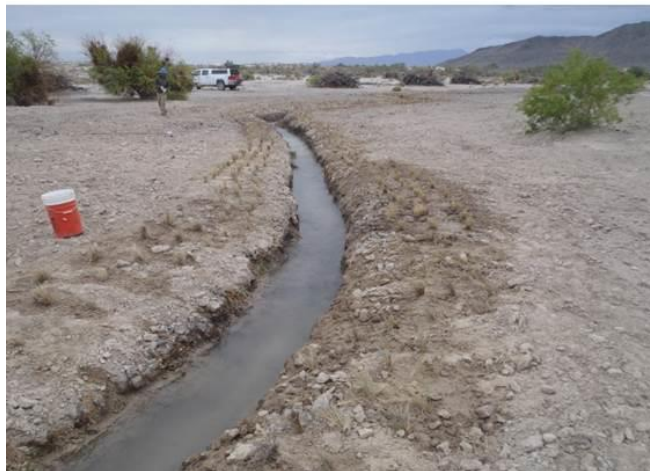
Figure 13. Saltgrass (*Distichlis spicata*) planting along restored stream channels, Rogers and Longstreet Springs, Ash Meadows National Wildlife Refuge, NV. Photos courtesy of Abram DaSilva, Great Basin Institute.

Ash Meadows NWR staff, along with NCC crews planted transplanted native saltgrass *Distichlis spicata* along the upper portions of Longstreet (445 m) and Rogers (168 m) Springs channels to prevent colonization of invasive weeds (Figure 13). Watering of native plants and manual weeding or herbicide treatment is on-going. This is particularly necessary for the Longstreet Spring channel, which is now directed through a barren agricultural field and likely contains a substantial invasive weed seed bank. Revegetation of the lower portions of the channels is unnecessary due to the minimal disturbance footprint (Figure 14).

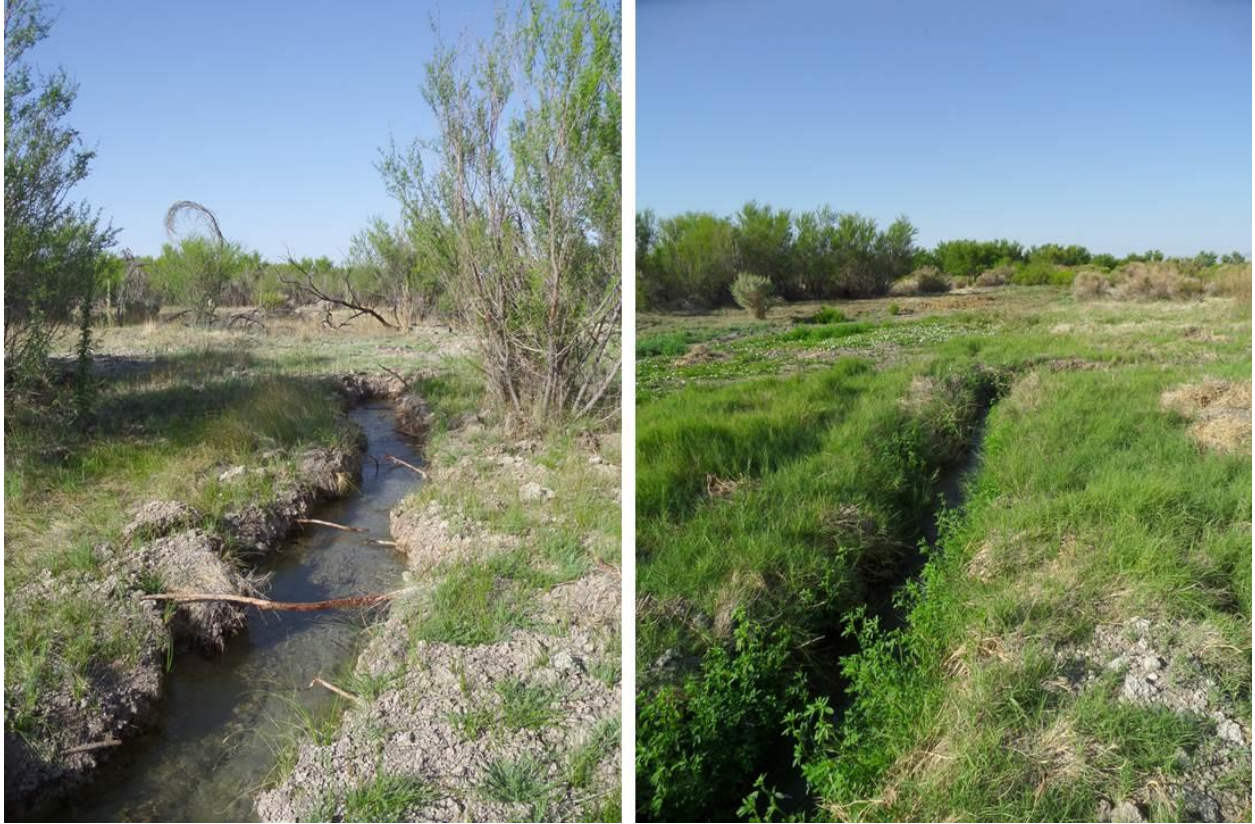
Figure 14. Example of minimal disturbance along the lower channel, Rogers Spring, Ash Meadows National Wildlife Refuge, NV.
